**United States Air Force
611th Air Support Group/
Civil Engineering Squadron**

Remedial Investigation and Feasibility Study

**Barter Island Radar Installation,
Alaska**

05 JANUARY 1996

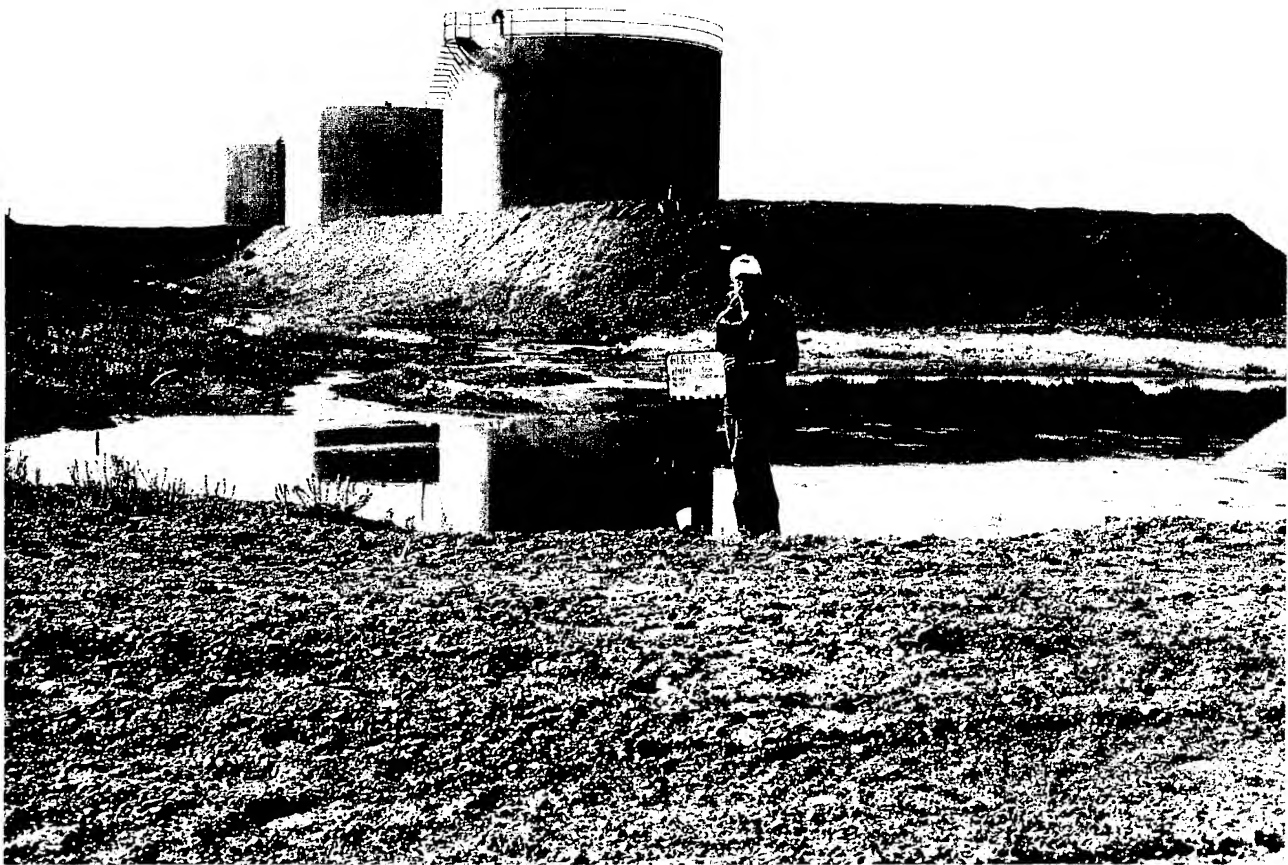
The POL Catchment (LF03) site is a tundra area surrounded by a berm. This is a view to the west from the east berm looking towards the POL Tanks (ST17) site. Note: vegetation (Alaska cottongrass) in catchment basin area not covered with water.

POL Catchment (LF03). This site is an almost rectangular, tundra area surrounded by a gravel berm (Figure 4-1, page 4-11). The site is located north of the module trains and directly east of the POL Tanks (ST17). The tundra area within the gravel berm is approximately 200 feet by 130 feet. The east portion of the bermed area consists of tundra and is dominated by a large pond. A small portion of the west side of the site consists of gravel, and there is a small stained area in the gravel at the base of the western berm. The POL Catchment serves as a secondary containment unit for petroleum hydrocarbons from the POL Tanks resulting from tank leaks and fuel spills. The POL Tanks area is a bulk fuel storage area for Arctic grade diesel fuel.

Sampling and analyses have determined that the POL Catchment (LF03) site is contaminated primarily with petroleum hydrocarbons. The contaminated areas are soil/sediment and surface water within the bermed portion of the site. In addition, a small stained area of gravel located in the western portion of the site is contaminated with petroleum hydrocarbons. The likely

sources of contamination are spills and/or leaks of diesel fuel from the tank farm just to the west of the site.

Levels of petroleum compounds (primarily diesel) detected at the site significantly exceed ADEC guidance cleanup levels, and migration of contaminants has occurred. Therefore, the site is recommended for remedial action. The contaminated area at the site consists of 5 cubic yards of gravel and 2,500 cubic yards of tundra. Passive bioremediation is the recommended alternative for remediation of both the gravel and tundra areas of the site.

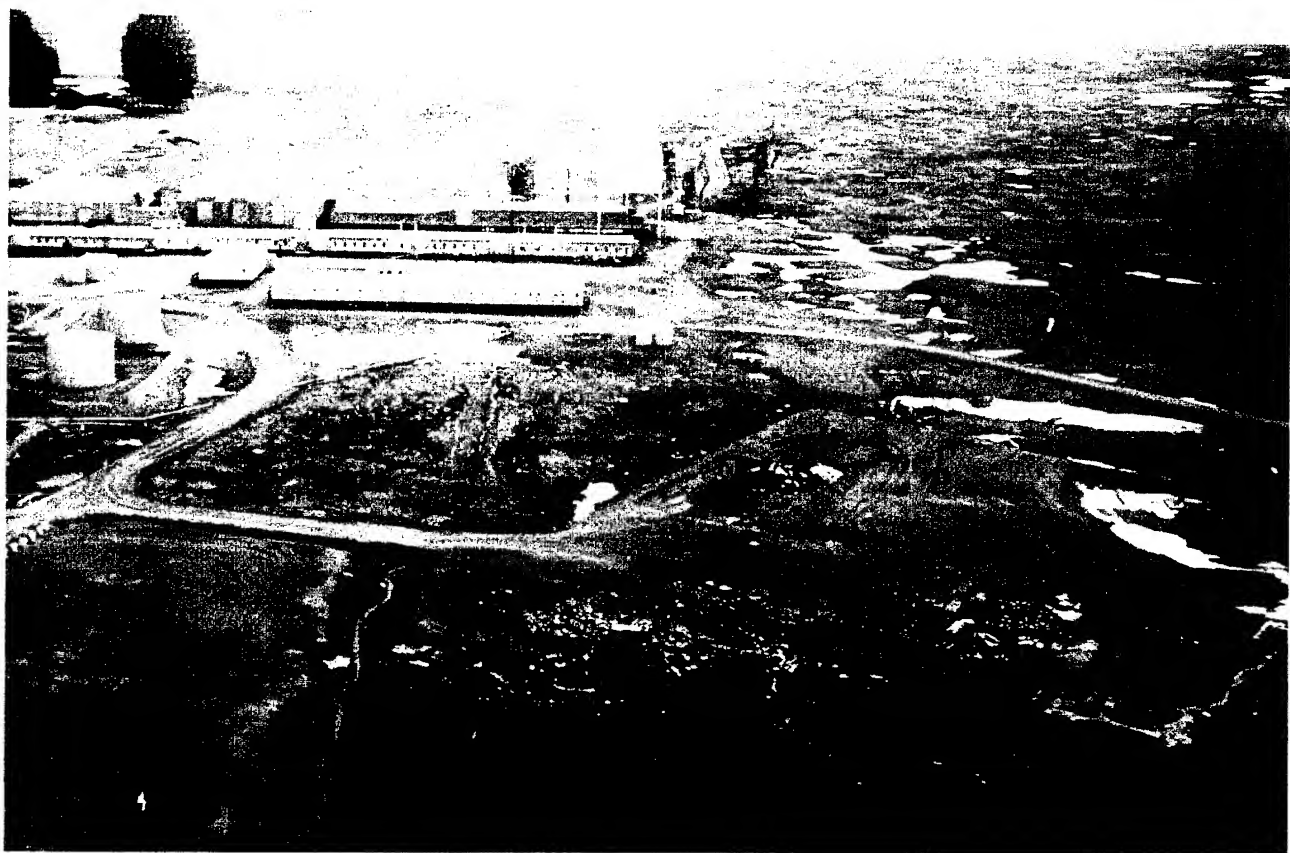
View to the south of the Current Landfill (LF04) site; right side of photo. Debris can be seen scattered along the north boundary of the landfill.

scenario in which the site surface water would be used as a drinking water supply. Even using the conservative future scenario, the potential human health risks at the site are not of a magnitude that normally requires remedial action. Based on the RI sampling and analyses, risk assessment and current site uses, remedial actions are not warranted at the site. No significant human health or ecological risks were identified at the site. Therefore, the Current Landfill (LF04) site is recommended for no further action.

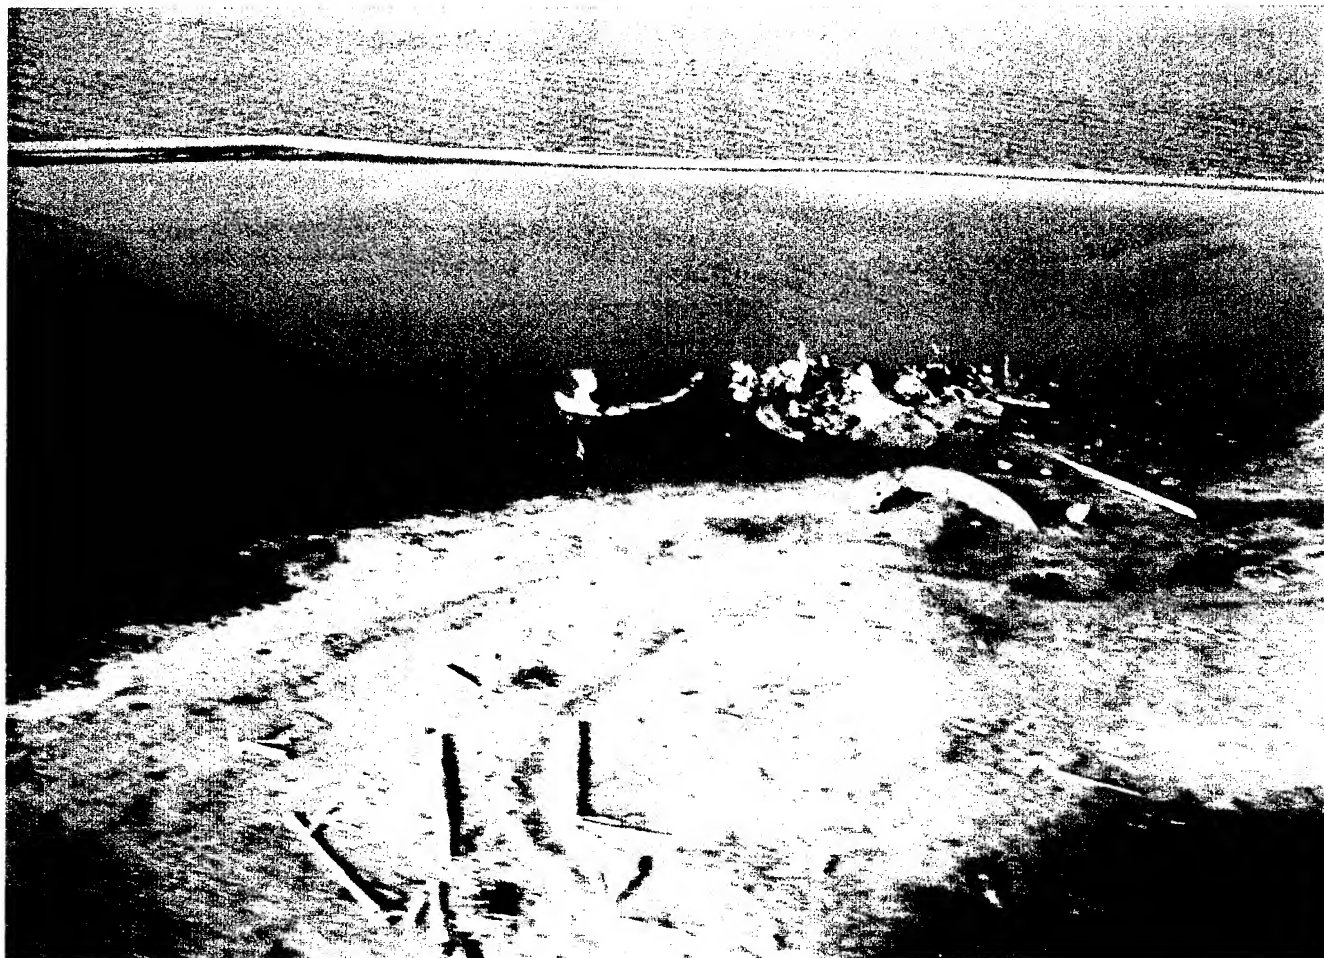
View to the north of the Old Runway Dump (LF12) site. Whale remains are currently dumped here by the local community to deter the polar bears away from the village.

Sampling and analyses have determined that the Old Runway Dump (LF12) is not contaminated; no contaminant was detected in site samples. The site is also subject to seasonal flooding by saltwater, and if contaminants were previously present, they were likely diluted by seawater. Since no contaminant was detected at the site, there appears to be no potential for contaminant migration, or risks posed by the site to human health or ecological receptors. Based on the RI sampling and analyses, the Old Runway Dump (LF12) site is recommended for no further action.

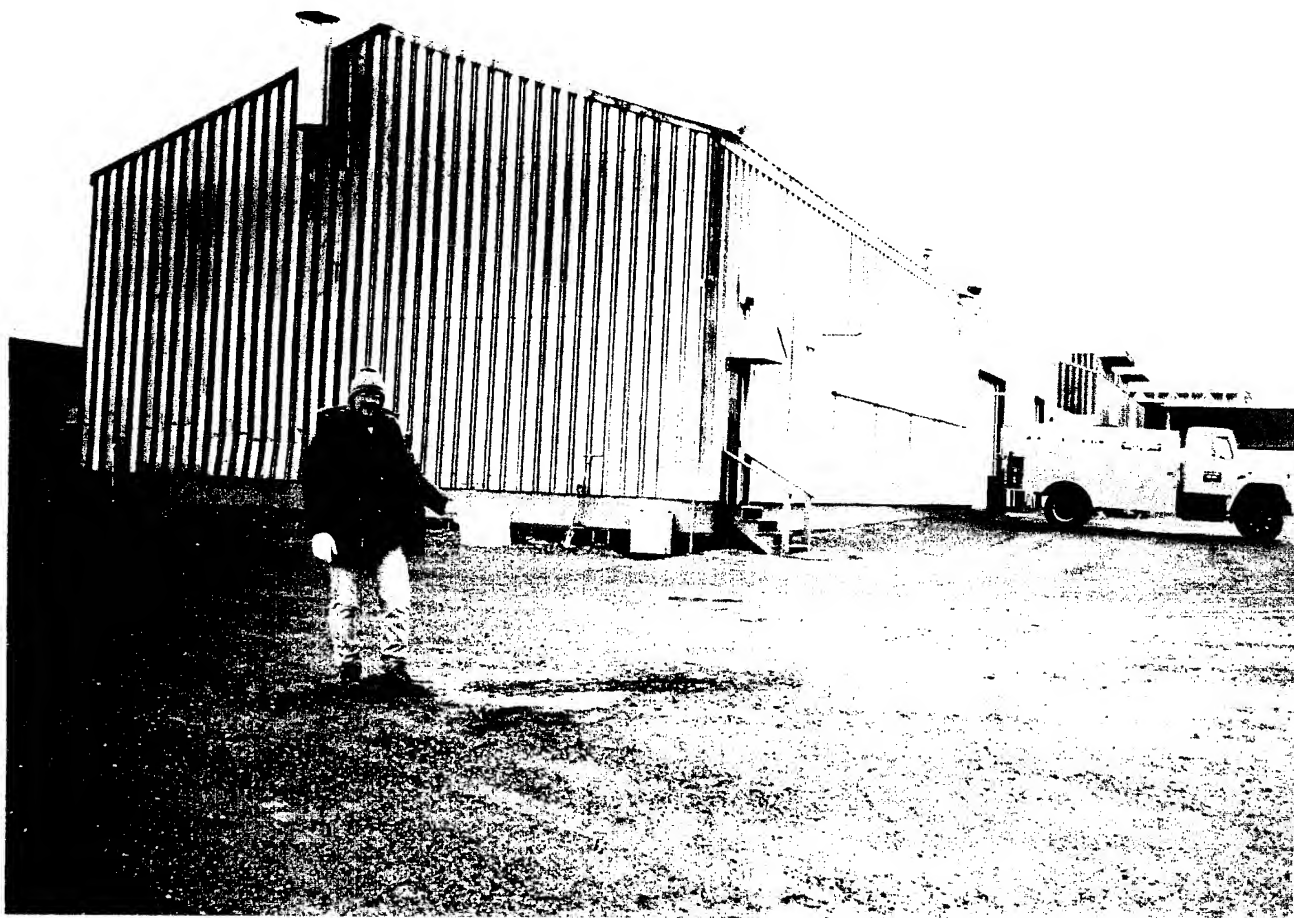
A view to the west of the east end of the Garage (SS14) site.

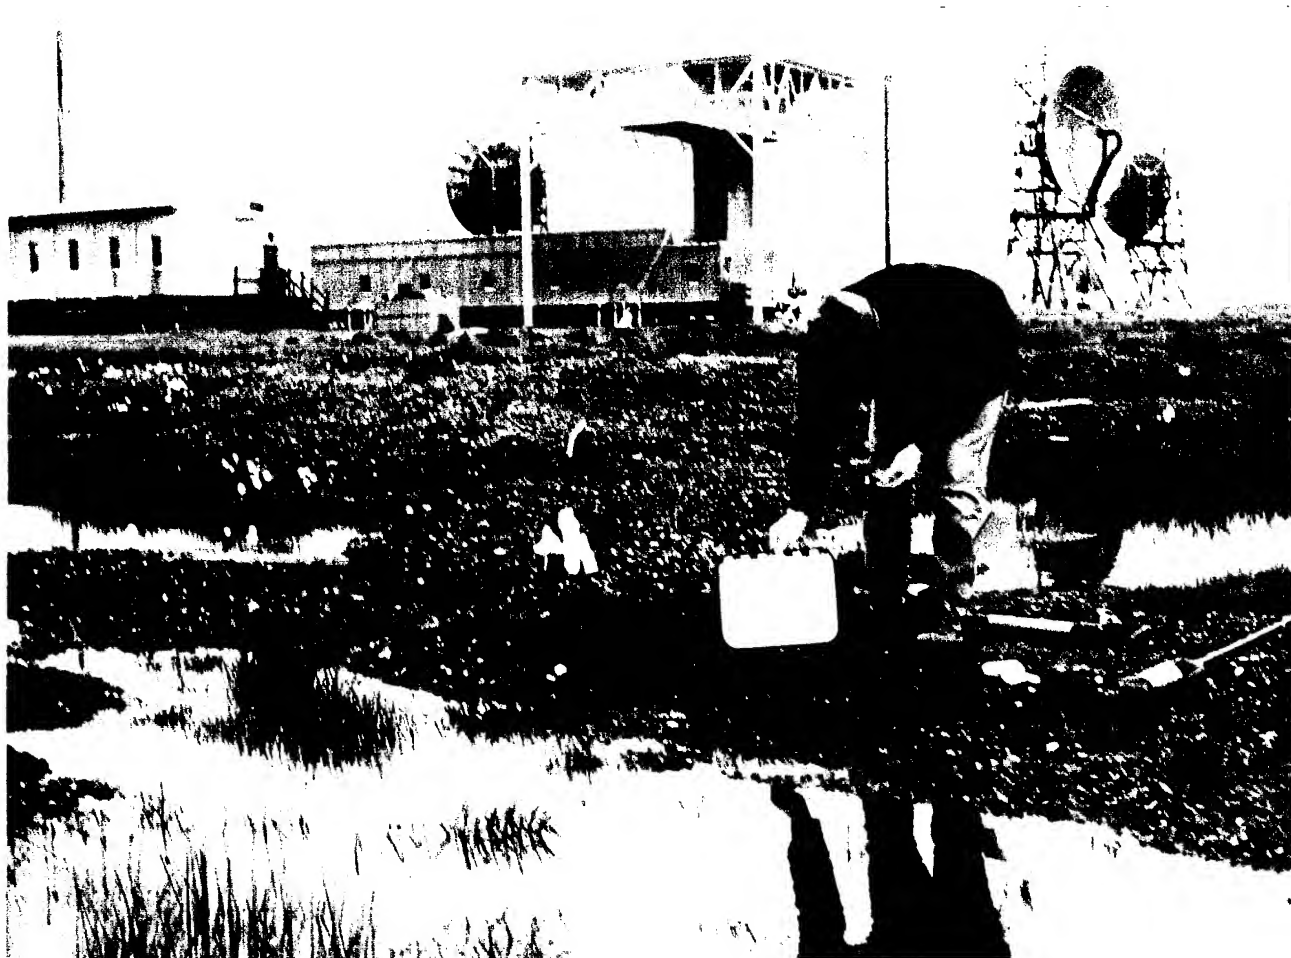
View to the southeast of the Bladder Diesel Spill (SS20) site located just west of module train B. Site personnel reported this area as the location of a historic spill.

Based on the RI sampling and analysis, risk assessment, and current site uses, remedial actions are not warranted at the site. Therefore, the Bladder Diesel Spill (SS20) site is recommended for no further action.

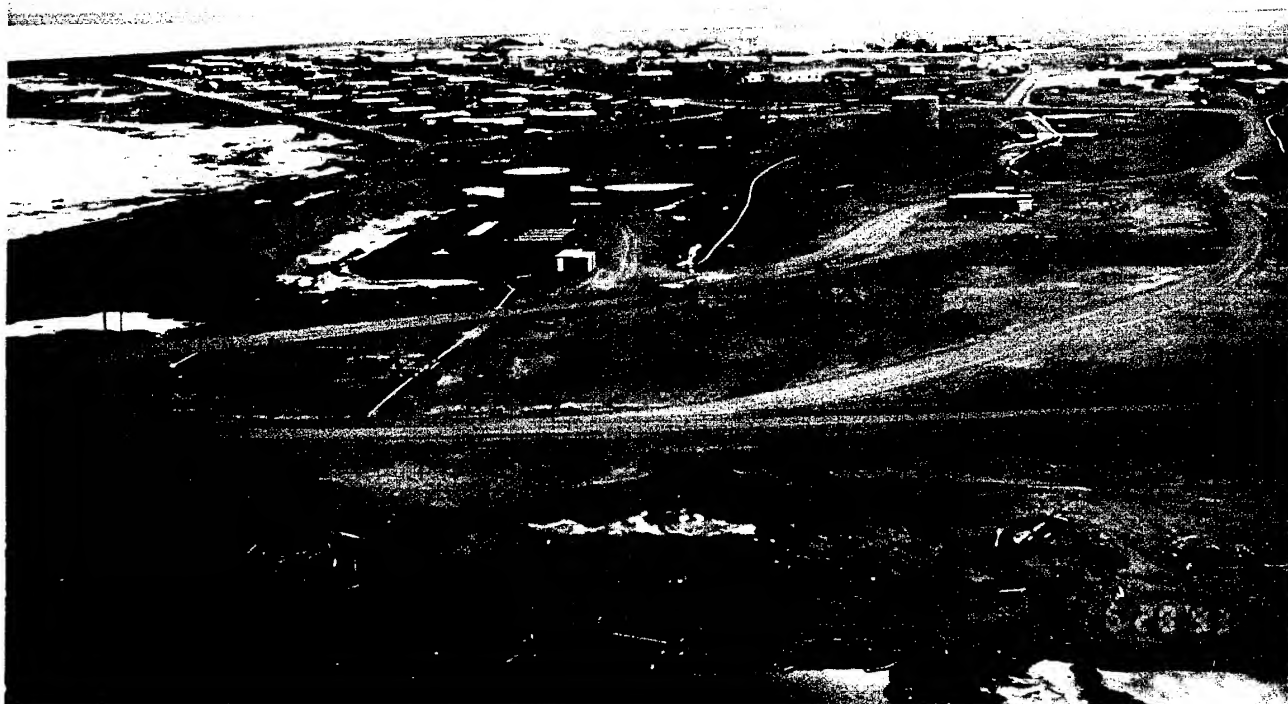
The JP-4 Spill (SS21) site. The arrow designates area in fuel line where the spill occurred. View is to the south with Kaktovik in the background.

Levels of petroleum compounds detected at the site exceed ADEC guidance cleanup levels but the extent of contamination is not clearly defined. Therefore, the site is being recommended for additional sampling in order to more fully characterize the extent of petroleum hydrocarbon contamination.
